SCIENCE FOR GLASS PRODUCTION

STUDY OF DEFECTS IN QUARTZ GLASS WITH THE ACTION OF HIGH-VELOCITY MICROPARTICLES ON PORT-HOLES

V. F. Solinov¹Translated from *Steklo i Keramika*, No. 8, pp. 9–12, August, 2010.

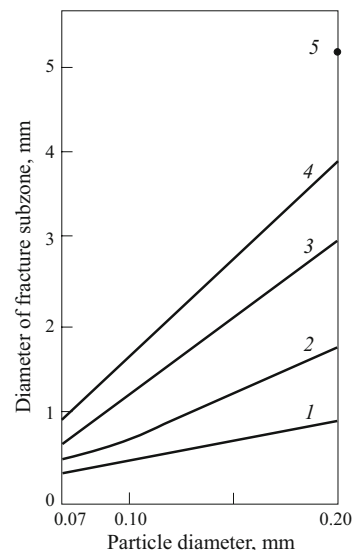
Fig. 5. Curves showing the dependence of the diameters of five fracture subzones in quartz glass on the impact of microparticles with different diameters.

Figure 5 shows the dependence of the diameter of the fracture subzones in quartz glass on the impact of microparticles with different diameter. It is evident that the size of the fracture subzones increases practically in direct proportion to the increase of the particle diameter.

The proven dependences enable us to determine the impact energy of the cosmic microparticles with the appearance of any defect on port-holes during ISS operation by studying the morphology of the entire fracture zone and the number of fracture subzones.

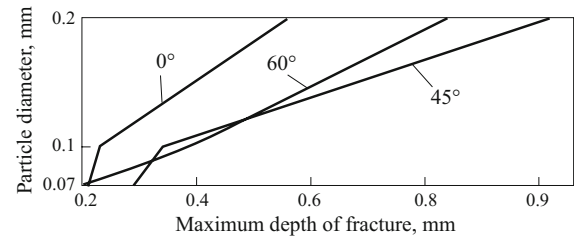
Figure 6 shows the dependences of the depth of defects in collisions occurring at different angles. It is evident that the fracture depth for an oblique collision is greater than for a vertical collision and, especially interesting, the depth of the defect at an impact angle 45° is greater than under 60° . At the same time the greatest diameter of the fracture zone is observed for a collision at zero impact angle. Apparently, these data show that for residual strength of the glass it is inclined collisions that are most dangerous. How can this be? Only tests for the residual strength of glass could give an answer to this question. Data obtained on the strength of samples by the centro-symmetric bending method are presented in Table 2.

This shows that the depth of a defect is not a criterion for evaluating the degree of danger which a defect poses for port-holes during the latter's operation.

**Fig. 6.** Depth of a defect in glass with microparticles striking a glass surface at different angles.

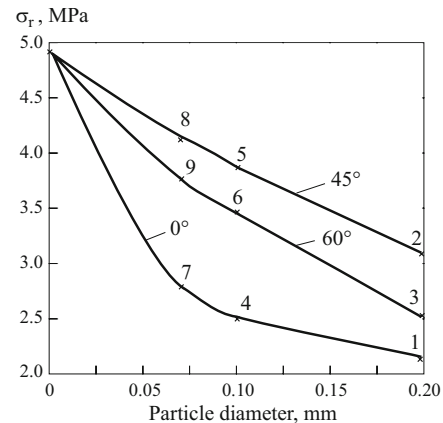
Figure 7 shows the dependence of the glass strength on microparticle diameter. It is evident that even negligible

damage of the glass surface (specimen 8) sharply affects the loss of strength of the glass. The data obtained on the strength for samples with particle collision angle 45° were unexpected. Even though the defects show the maximum depth the specimens have the highest residual strength.

**Fig. 7.** Residual strength of glass σ_r versus the diameter of the particles for different angles of impact against a glass surface.
